Title: Installation of Ramps and Utility Cabinet at TA-18-1 Slotin Building

Installation of Ramps and Utility Cabinet at TA-18-1 Slotin Building

Historic Building Report No. 395

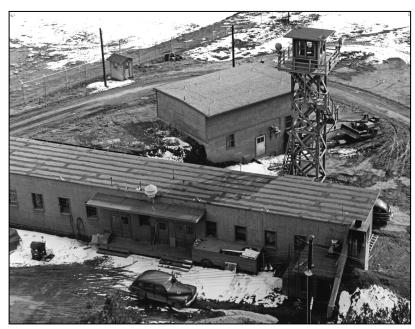
be Figure 1. Historic View of TA-18-1. North and west elevations of the Slotin Building (high bay building) are visible.

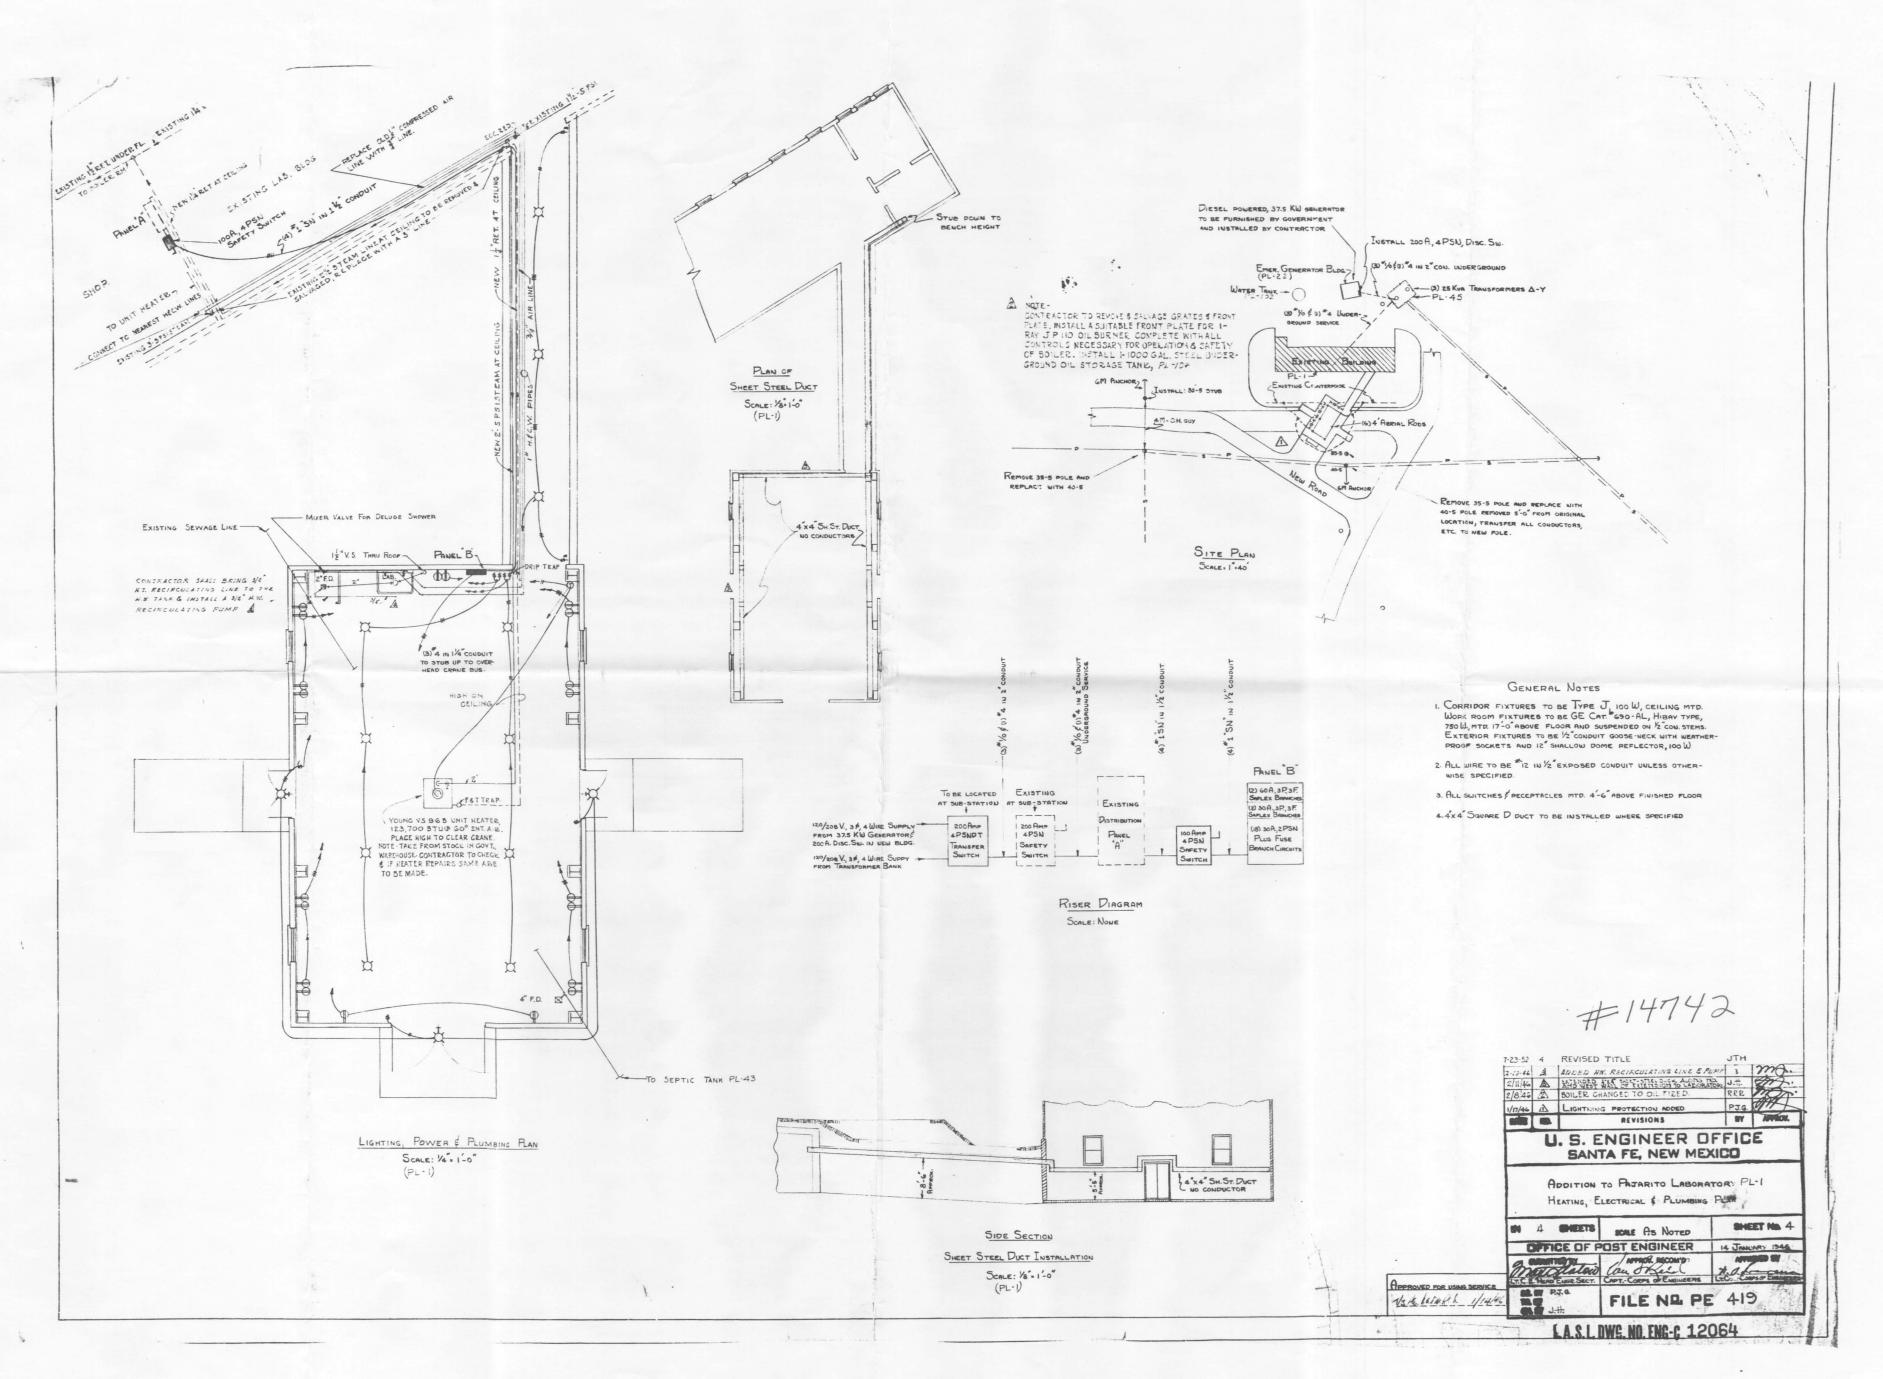
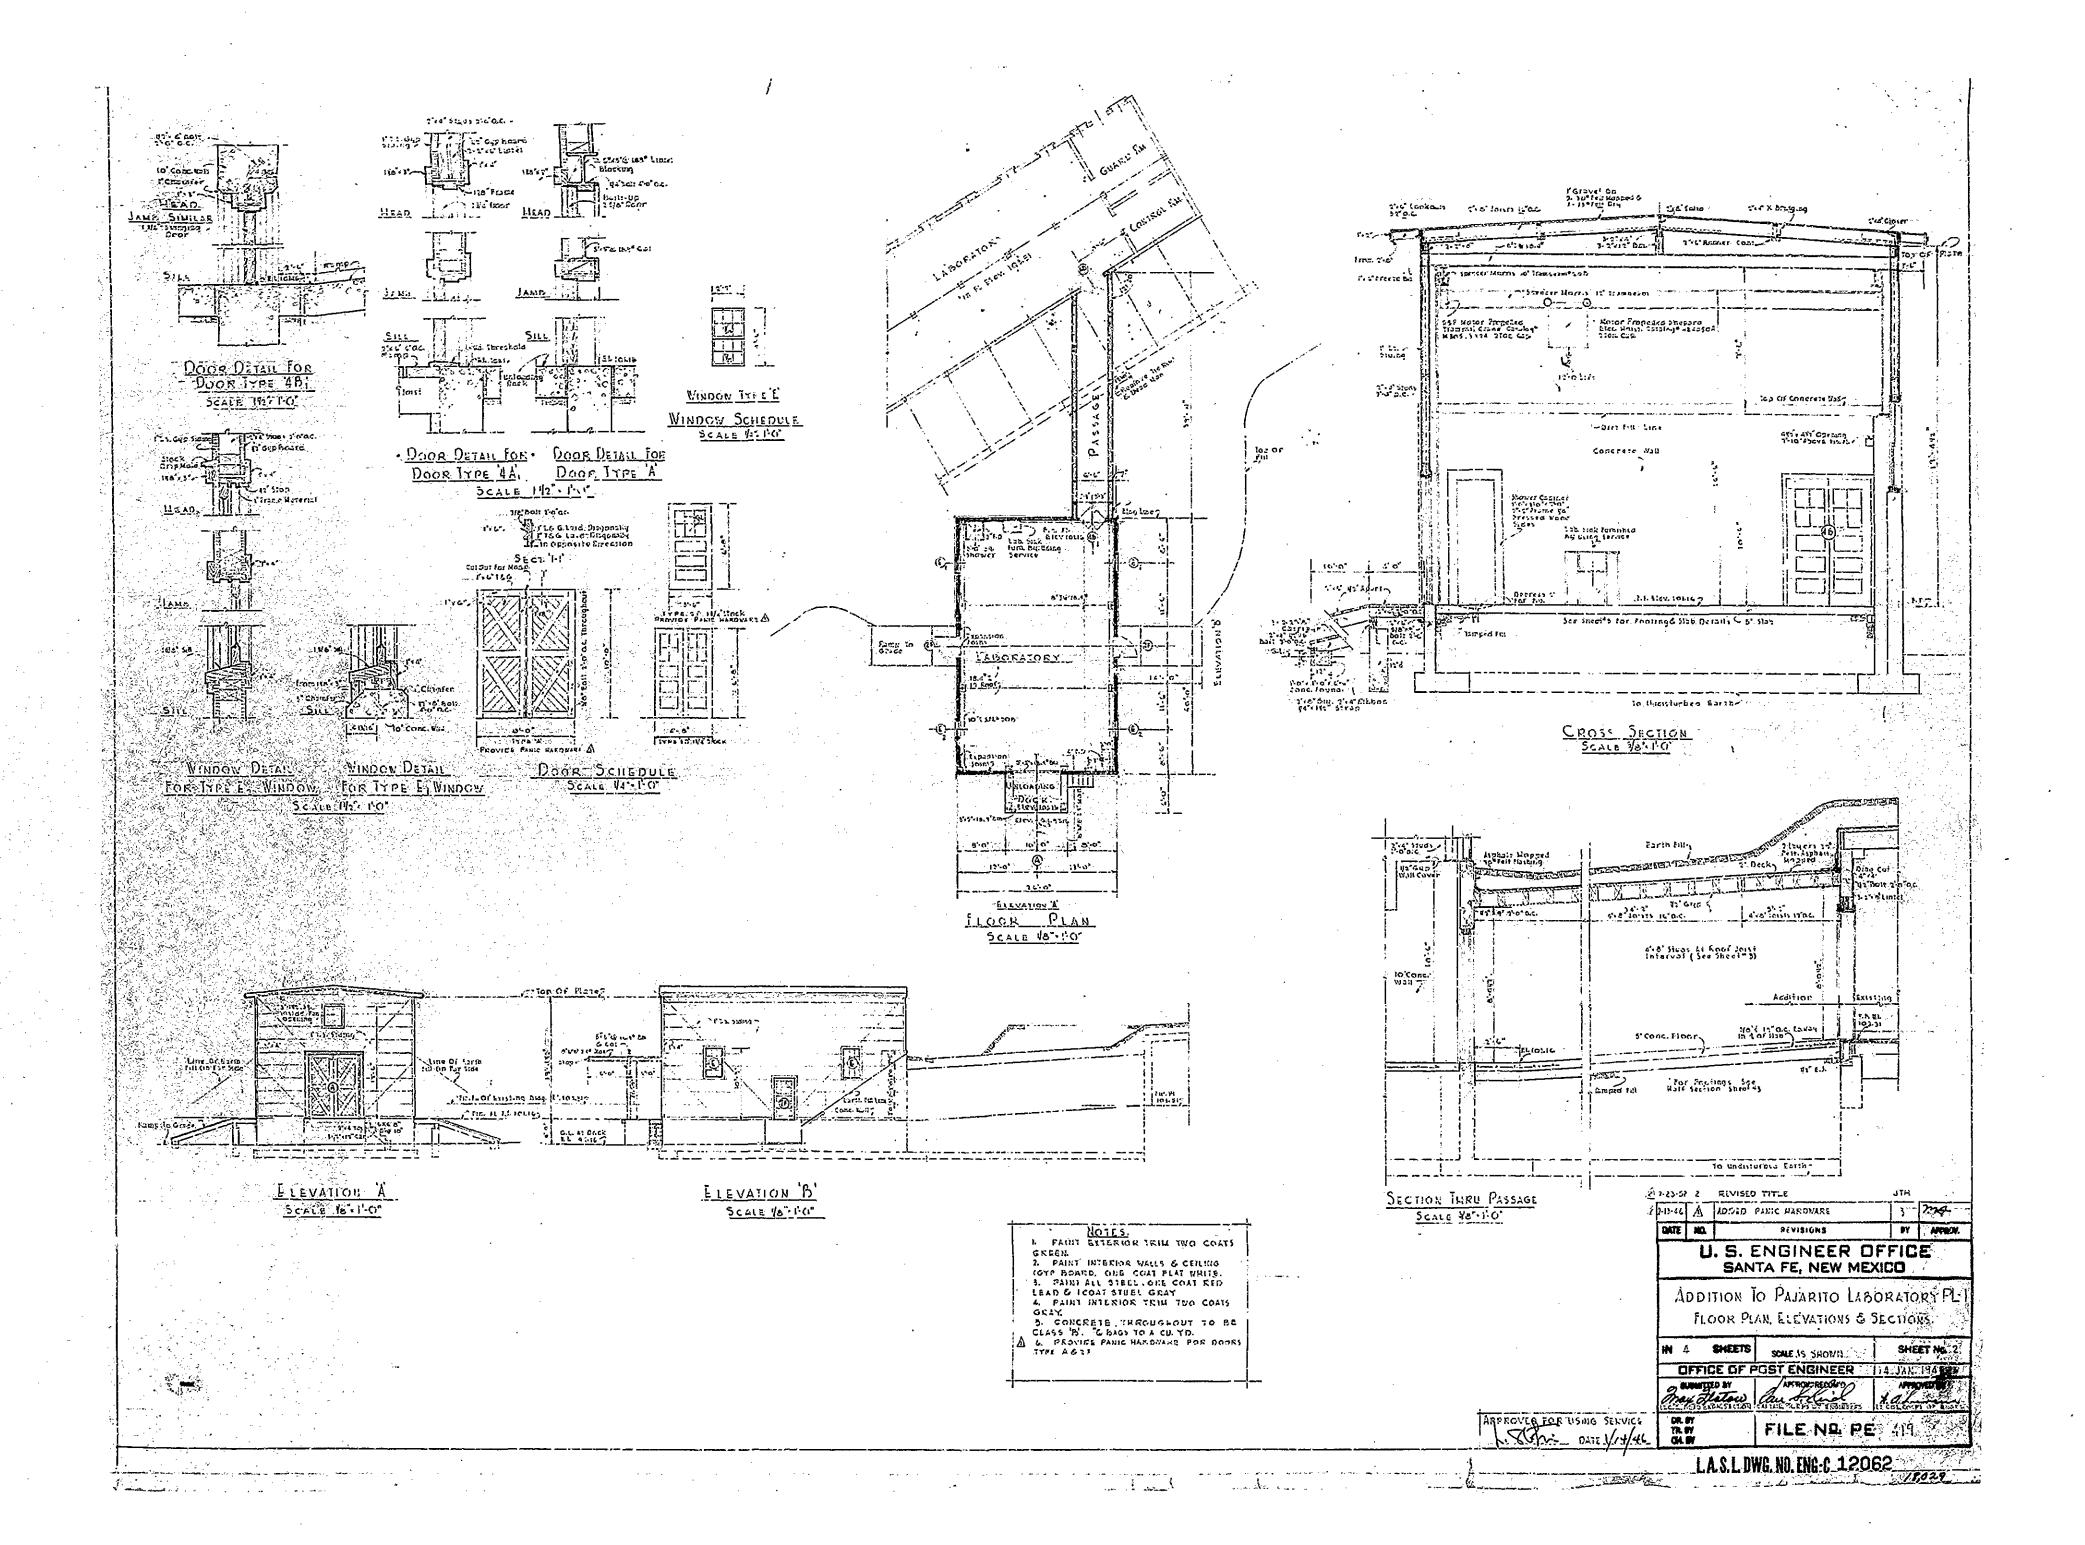
Original Drawings of TA-18-0001 Annex (Slotin Building)

The Field Office proposes the addition of two entrance ramps leading from the ground surface to the east (yet to be constructed) and west elevation entryways. While ramp designs are preliminary at this stage of planning, the aim is to construct ramps consistent with historic designs, but recognizable as new construction. Construction material would consist primarily of wood and measurements would be approximately 15' 0" x 5' 0". The proposed dimensions and material of construction is in accordance with original plans (Enclosure A).

Original construction drawings indicate the dimensions and basic design of the two doors (Enclosure A). This information will be used to guide the reconstruction of the doors and to provide access to a furred-out utility cabinet (Enclosure B: Sheet SK-1). The construction of a utility cabinet will serve to hide unsightly utilities while also providing an opportunity to exhibit the doors – architectural elements important to the story of the Slotin Building. This action will allow for better interpretation of the Slotin Accident, which is the reason that the building is a part of the Manhattan Project National Historical Park.

reconstruct the ramps to the approximate measurements. Grading limitations may alter the length of both ramps in response to current ground slope and modern accessibility requirements of 1:12 slope. Period photography indicates that the ramps were constructed from wood, which will be the case for this new construction.

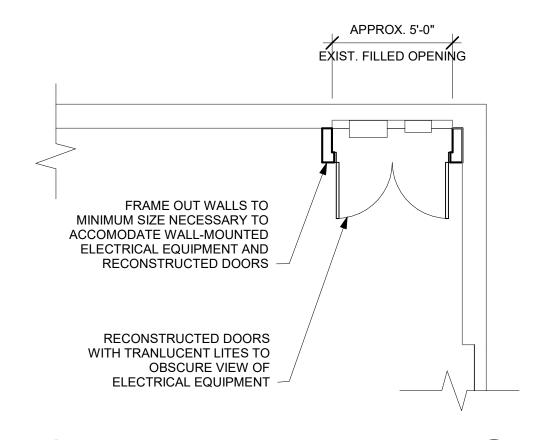
3 PARTIAL FLOOR PLAN SK-1 1/4" = 1'-0"

In addition to the installation of two entrance ramps, the Field Office proposes to install a utility cabinet in the east corner of Slotin Building. At present, non-period utility lines cover many of the interior surfaces throughout the building. As part of the parent project referenced in the introduction, many of these utility lines will be removed or rerouted to a more centralized location. One example is the electrical panel that can been seen in the 3D Rendering Facing East detail (Enlosure B: Sheet SK-1). The Field Office intends to redirect necessary utilities to a central location on the east portion of the north wall.

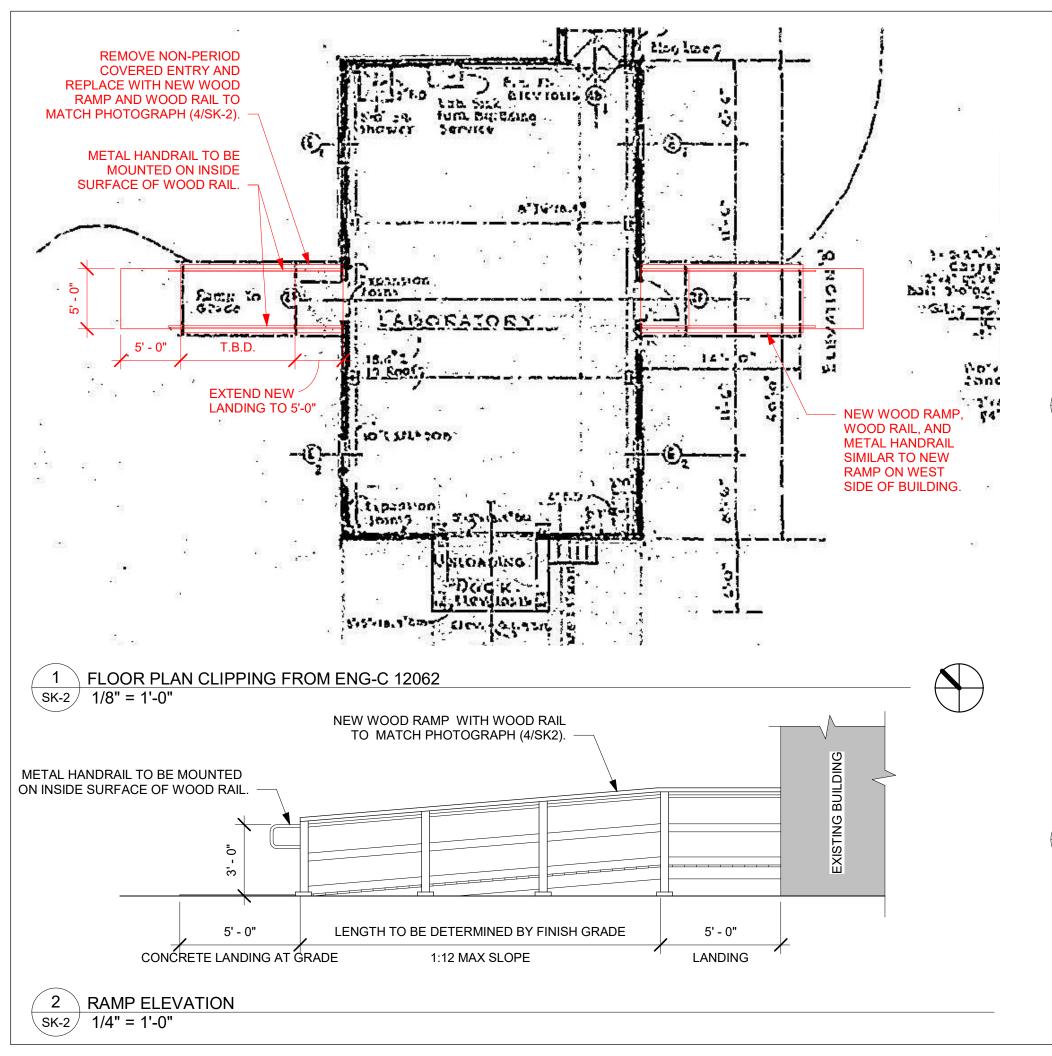
Likewise, the Field Office intends to reduce the original slope of the ramps and to construct a handrail system on both sides of the two ramps (Enclosure B: Sheet SK-2). While the wooden handrails will not fall within the original design concept, the Field Office has confidence that a handrail system can be designed and installed in a manner consistent with the historic character of the building considering other Manhattan Project buildings had similar railings (Enclosure B: Sheet SK-2).

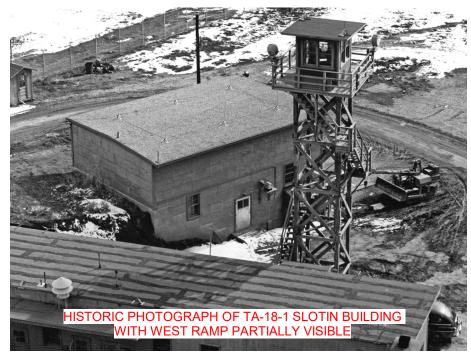
3 SITE PHOTOGRAPH 6K-2 NO SCALE

The grade surrounding the Slotin Building does not presently represent the historic grade. This is due to numerous factors that include Cold War development and demolition of nearby buildings, and the addition of asphalt paving around and immediately adjacent to Slotin Building. In order to achieve a suitable grade for the entrance ramp installation, it may be required to remove existing asphalt around the building, and add earthen fill. Asphalt paving does not fall in line with the historic character of the site during its period of significance, and its removal would be beneficial to overall character and feel of the building exterior. Historic photography (Figure 1) indicates that the area surrounding the Slotin Building was dirt during the period of significance. A neutral color crusher fine that blends well with the surrounding dirt would replace the asphalt where removed to prevent soil erosion and muddy conditions during rain and snow events while also keeping in line with the historic character of the site.
